SAFETY ALERT

Safety Alert No. 415
March 8, 2021

Inadequate Preparations in Advance of Inclement Weather Results in Excessive Rig Damage and Risk to Personnel

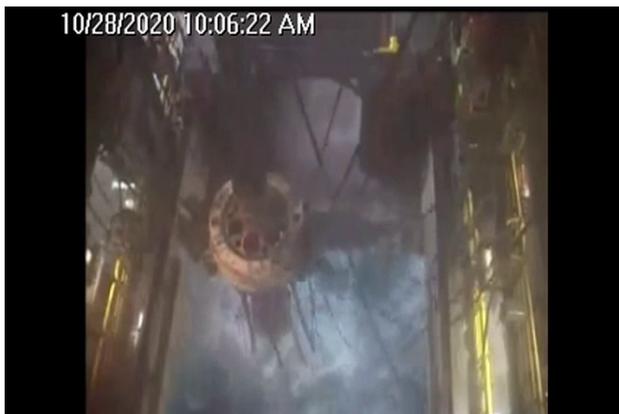
Figure 1: Riser in contact with the hull after the EDS

After the EDS was initiated, the riser contacted the hull in the moonpool (*figure 1*) due to the severe swells that formed throughout the storm, causing damage to the riser (*figure 2*). Furthermore, the LMRP endured damage to its frame, piping, and coflex after contacting the seafloor several times. A comprehensive property damage assessment was conducted by the operator and rig owner in the days following Hurricane Zeta. Inspectors determined that the tensioner, flex joint, telescopic joint, LMRP, riser joints, cabling, and other riser-related components had sustained significant damage.

- Analyze and confirm design limitations of risers, tensioners, LMRP, and other critical well operations equipment.
- Evaluate the direction of disconnect for potential contacts to the LMRP and associated equipment with the seafloor.

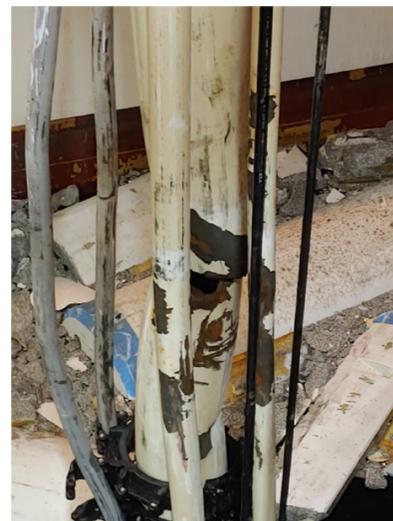
Figure 2: Ruptured Riser Joint
