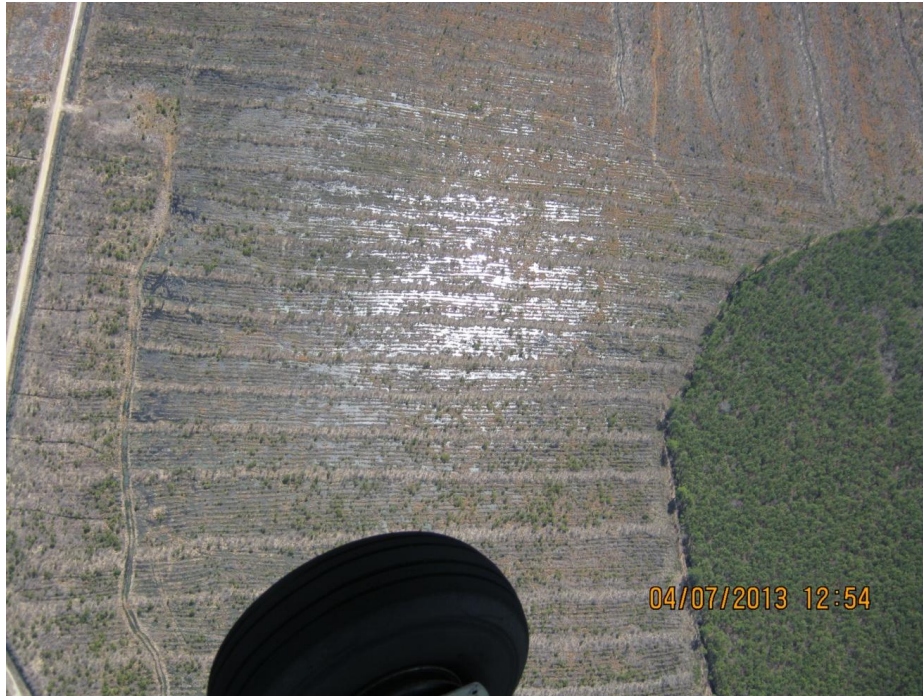
Photo 1, April 2013: This aerial photo shows sunlight reflecting off standing water on areas that the Norfolk District Corps delineated as only partial wetlands.

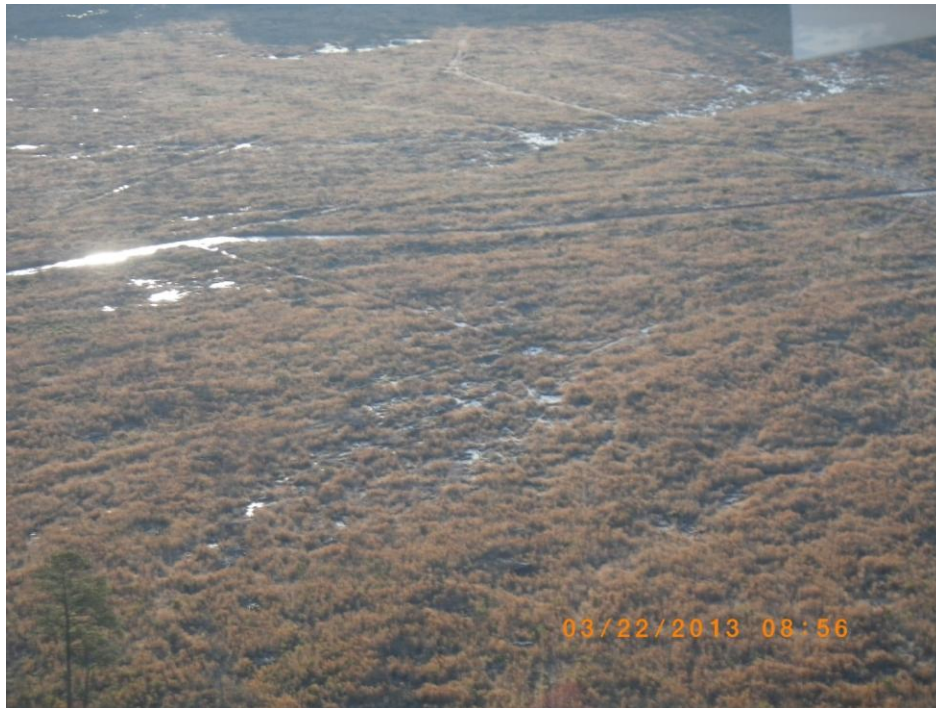
Photo 2, March 2013: This aerial photo shows wide spread primary indicators of hydrology above ground. Even through vegetation 2-3 feet high, standing water is evident across large portions of the site.

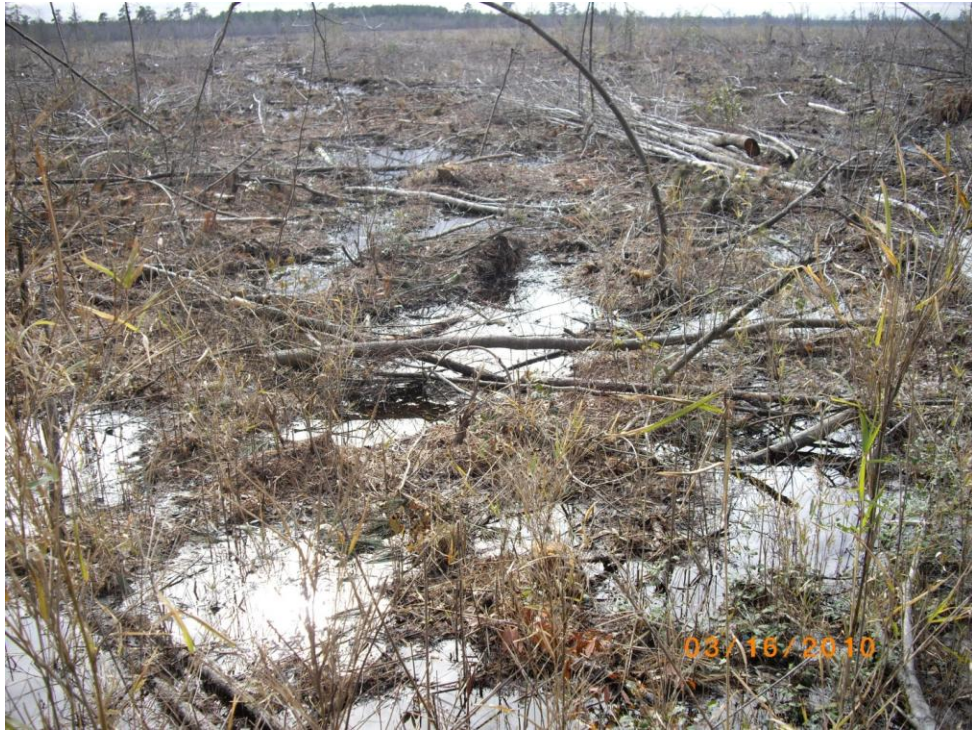
Photo 3, March 2010: This photo, taken in a normal rainfall year, shows the wetland conditions at the site, typical of some areas the Corps delineated as non-wetlands. PEER believes the Corps incorrectly based its delineation on an improper ditch drainage "model" rather than actual field conditions.
