**IAQ Incident Involving Insecticide Application and Acute Odorant Release:
A Retrospective Review**

Prepared For: Eastern Research Group, Inc. (ERG)
USEPA/OARM/OA/SHEMD

Review Conducted By: HP Environmental, Inc.

Report Release Date: August 26, 2014

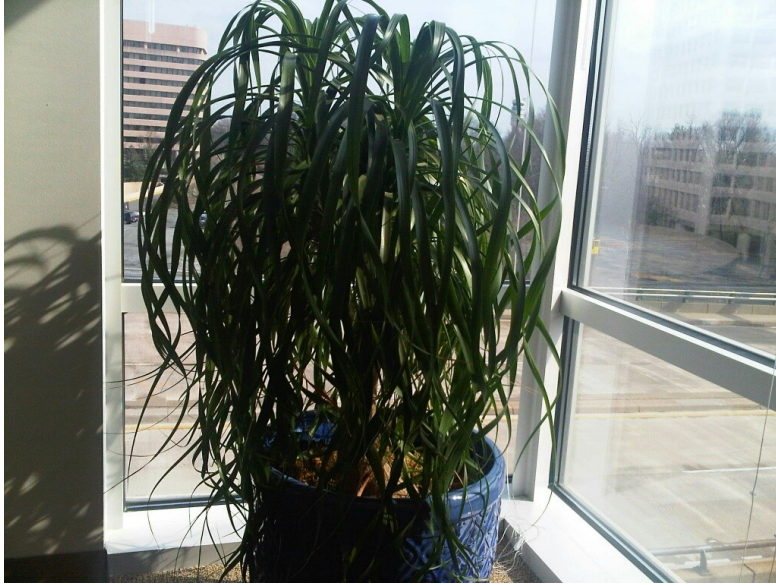
i Photo of ponytail palm positioned near the office window.

A perimeter corner office space measuring approximately 12' x 18' was occupied by a single person. For approximately 3.5 years a plant, which was given to that person as a gift, was positioned in this officeⁱ. The plant, a Ponytail Palm (*Beaucarnea recurvate*), hosted colonies of mealybugs (*Maconellicoccus hirsutus*) for most of the previous 3.5-years. At the same time the plant was placed in the office a single bottle of household insecticide was purchased to control the mealybugs. This insecticide product was identified as "Garden Safe® Brand Houseplant & Garden Insect Killer"ⁱⁱⁱ. The product was contained in a 750 mL bottle equipped with a manual "trigger" spraying apparatus. The bottle of insecticide was stored near the plant in the office where it was exposed to sunlight. Approximately once every 4-6 weeks the insecticide was applied to the plant and these treatments were effective in controlling the mealybugs. Use of this insecticide product continued in the office area without incident for approximately 3.5 years, prior to July 3, 2014.

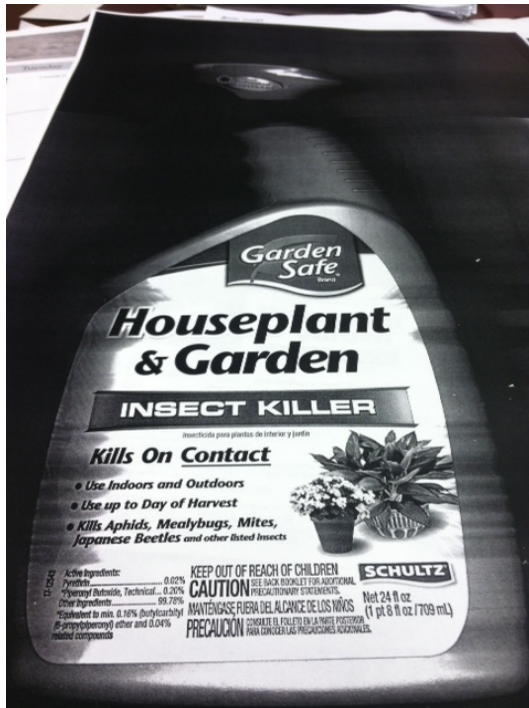
ii A scan of the insecticide bottle showing the label and ingredients.

“Garden Safe® Brand Houseplant & Garden Insect Killer” contains two reported ingredients, Pyrethrins (I) (this insecticide accounts for 0.02% of the total product) and Piperonyl Butoxide (referred to as “PBO”, this non-insecticide synergist accounts for 0.2% of the total product). These two product components are dissolved in water (aqueous solution) and together represent the entire reported product composition (100%).
